Ancient Road Conservation Volunteers

POCKSTONES MOOR PROJECT 2000

Report by Paul Sinkinson
DALETRAX LIMITED
01423-322011

ROUTE INSPECTION 11/12.04.00

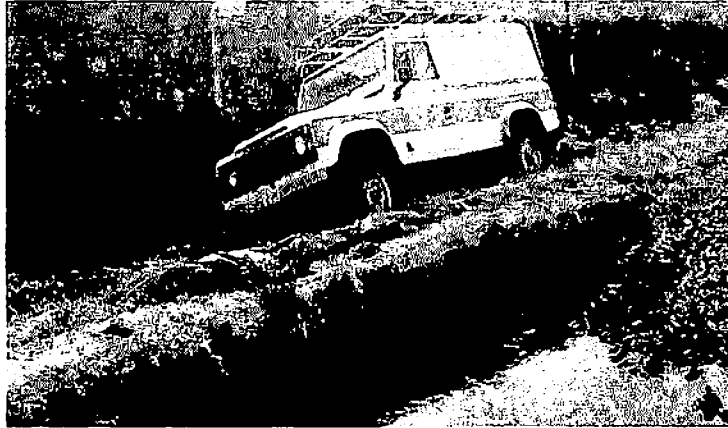
THIS YORKSHIRE DALES NATIONAL PARK LANDROVER BECAME BOGGED DOWN AVOIDING THE ERODED SECTION

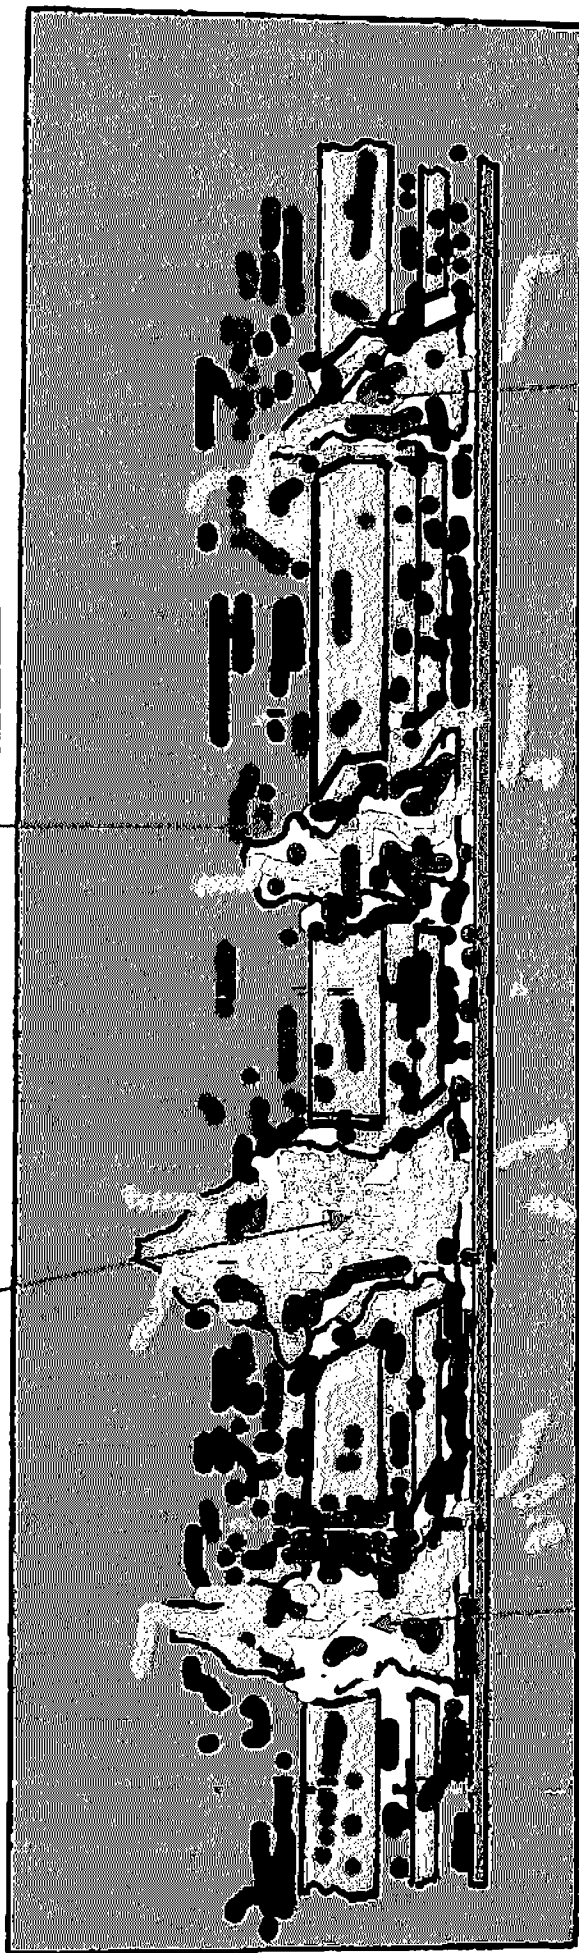
THESE PHOTOGRAPHS AND
THE DIAGRAM INDICATE THE
MAIN AREAS OF EROSION

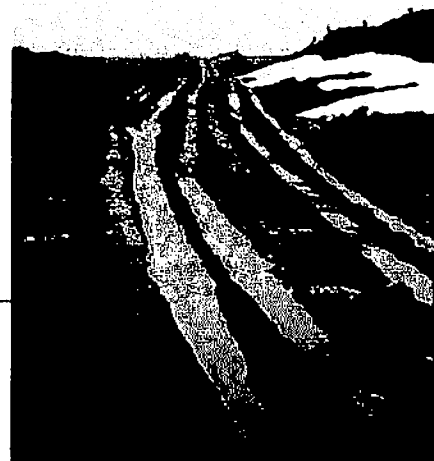
THE UGLY

This section of road although recently repaired, is standing in water due to vertical stress caused by too fine a stone surface being used. When water has flowed over from the side ditch this has saturated the gravel resulting in ruts.
