A Sustainability Assessment Process for Trail Management

The Motoring Organisations' Land Access and Recreation Association

The Pre-emptive Sustainability Assessment Process (P-SAP) in advance of DMMO Claims.

September 2005

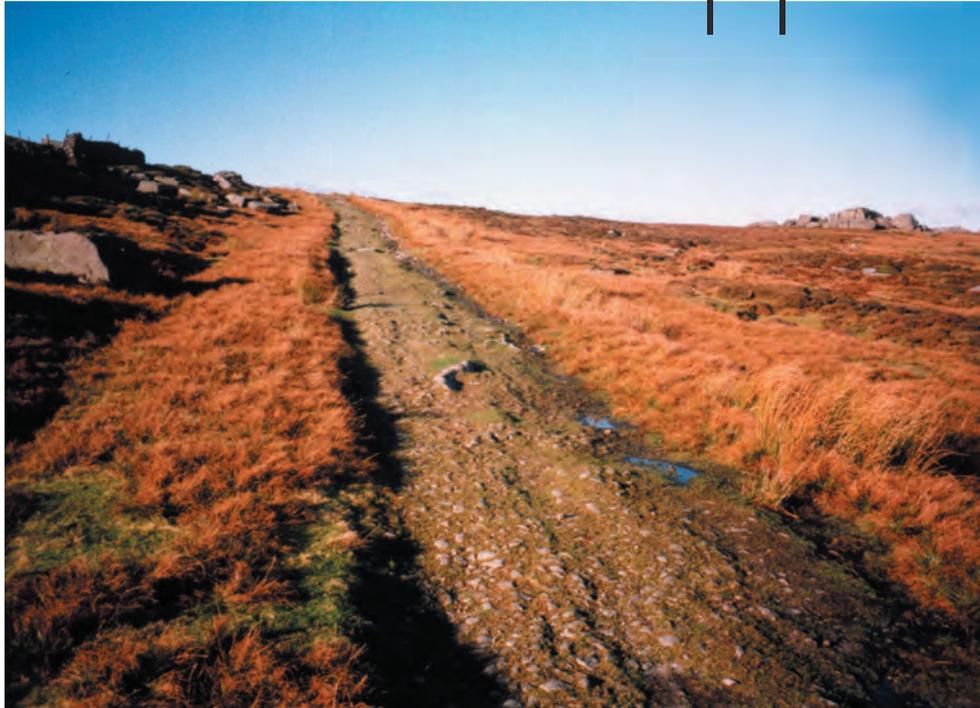
Grid reference 99/108603, looking west-northwest.

The Forest Road/Park Road, across Pockstones Moor (between Harrogate and Pateley Bridge), North Yorkshire. The through-route is 5.4 miles long, with a ‘Y’ fork to Skyreholme three-quarters of the way along, and was set out in the Forest of Knareborough Inclosure Award of 1770 as a public carriage road for all types of traffic. There is also documentation to show that the road pre-existed the inclosure award. The road is on North Yorkshire County Council’s list of streets as an unclassified road.

The road surface is well-laid stone metalling, now varying in quality through the passage of time, and with some recent repairs still visible as stone of a different kind to the original. There is a properly engineered drainage system of side ditches and stone culverts under the road at the highest point, where water running off the higher fell (to the left in the photograph) makes the ground marshy.

The road surface is durable - only short lengths have required maintenance during the last 30 years, and this was due to the ditches and culverts choking and eroding the metalling from beneath. Apart from two badly water-scoured short sections (now repaired), the road has been, and is, readily usable by all classes of traffic.

The south-easter two-thirds of the route lie in the Nidderdale AONB, and the northerly third in the Yorkshire Dales National Park. The moorland to the north is a valuable habitat for birds, and in part wetland, but apart from localised deviation before the repairs, vehicles have no need to, and do not, depart from the made-up carriageway.

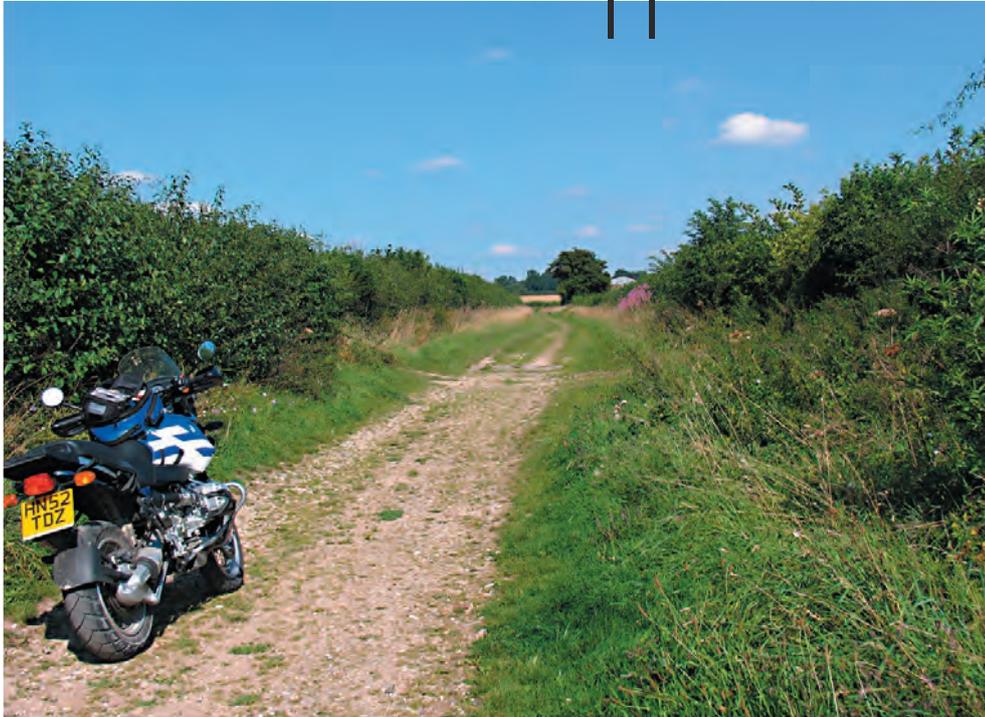
Grid reference 185/318324 looking north-northeast

This section is recorded as unclassified road, and runs from just south of Broughton (GR 185/3132) northeastwards for just over half a mile, whereupon it changes status to BOAT (a former RUPP) for a further 1.8 miles.

The only section with conditions problems is where the local authority dug trenches to exclude ‘new age travellers’ some years ago, and never repaired these when the ‘NAT threat’ diminished.

The surface is very durable chalk and flint, self-draining, and able to withstand considerable heavy agricultural use. The passage of vehicles helps prevent the hedges and verge greenery encroaching too far into the lane. There is plenty of width to allow different types of traffic to meet and pass safely.

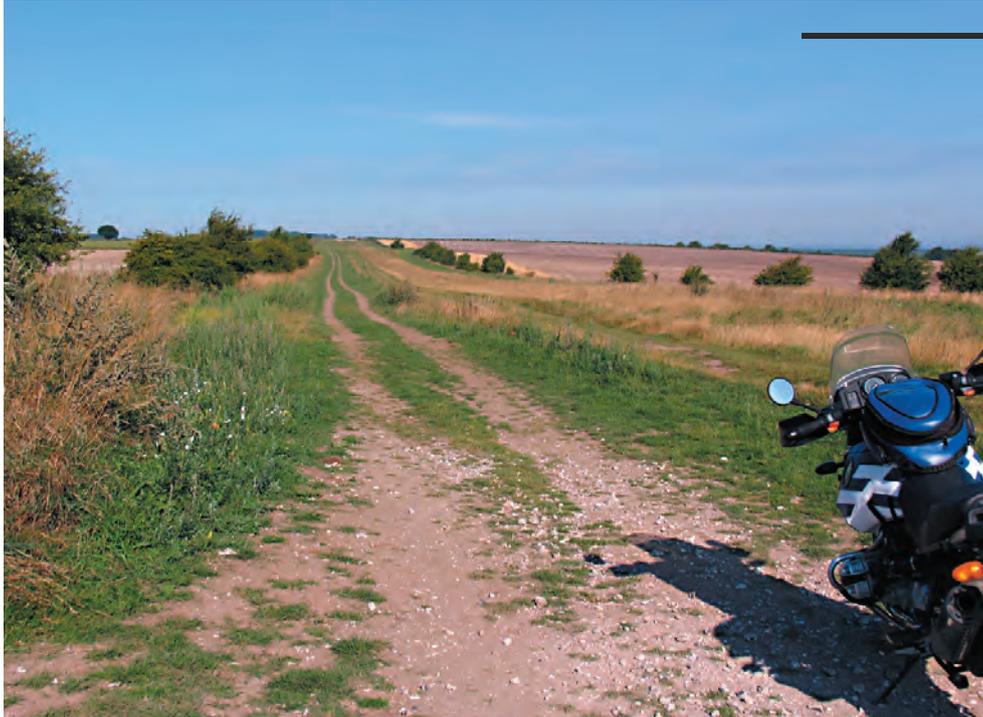
Grid reference 174/487835 looking west-northwest.

The Ridgeway at Gore Hill, just west of the A34(T). The Ridgeway is part of an ancient route system, linking the crossing of the River Thames at Streatley, with the Vale of Pewsey, and connecting beyond into the southwest peninsular of England. There is a network of these ancient trans-Wessex routes, including the upper and lower Icknield Ways, the Inkpen Ridgeway and the Harroway.

Like most wide ancient roads in this area, much of the Ridgeway is used for access to farms and by heavy farm traffic. Experiments have been tried to get motor traffic to use a metalled strip, but experience shows that cyclists and walkers immediately colonise this instead.

In terms of route resilience, recoverability, width, links with other routes, and sheer length, the Ridgeway would normally fall into Pre-SAP category 1, and Post-SAP category green. The fact that it is part of (or, in this case comprises) a National Trail affects that normal assessment. The Ridgeway has been subject to several investigations, reports and at least two public inquiries into possible traffic regulation. In 2004 the Minister instructed the various highway authorities along the route to impose a seasonal restriction on recreational motor vehicle use, primarily to prevent ground damage in and after wet weather. This prohibition is intended to run from the end of September to the end of May each year. There will be varying arrangements for feeder and cross-Ridgeway routes. Similar management arrangements may be necessary on other vehicular routes that have been incorporated into National Trails.

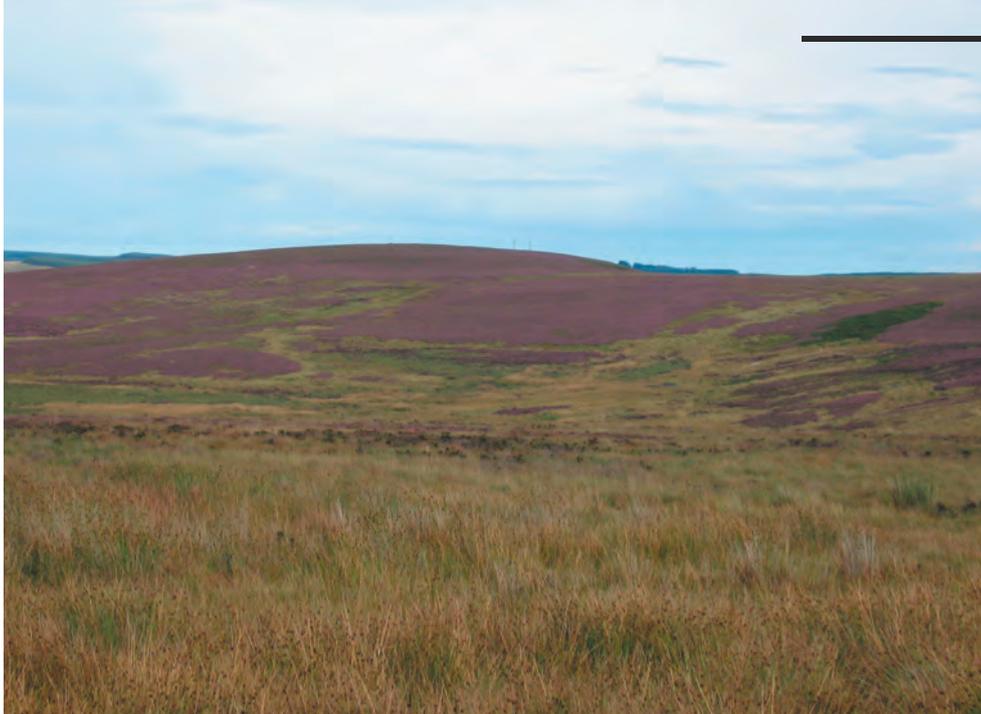
Grid reference 80/857890, looking northeastwards. The route ran over the saddle to the right (south) of the rounded hill.

Brigg Road is set out in the Corsenside and West Woodburn inclosure award of 1795 as a public carriage road. It currently has no recorded status and enquiries suggest that no recreational motor users, equestrians, or cyclists, know that the public right exists, or use the alignment.

Other than some vaguely ‘linear marks’ on the ground, approximately on the course of Brigg Road, there is now no clear trace of the route, although county maps of 200 years ago suggest that it was once visible and used. The ground is reedy and prone to dampness and it would be inappropriate to introduce MPV use.

The route should certainly be made available to equestrians, for whom it would be a valuable link in the network. Cyclists would generally find it hard going, even in summer.

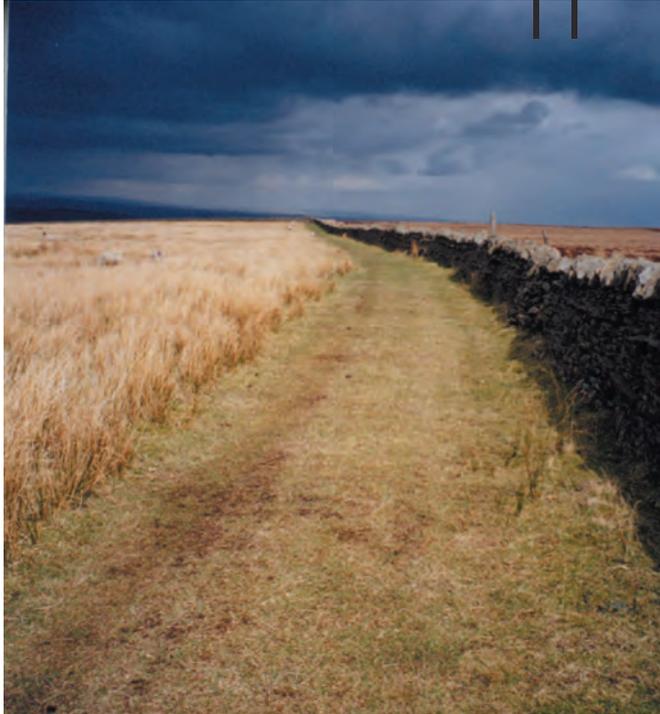
Grid reference 86/755528, looking northeastwards.

‘The Long Bank’ – an ancient route that was improved under a turnpike act in the late 1700s, then this section was bypassed by further turnpiking works in 1823. There is a proper stoned surface under soil and grass deposits of almost 200 years, and the route is very resilient and capable of taking most traffic in all weathers.

The reason for the 1823 bypass was that the northern end of this section is very steep – too steep for efficient horse-drawn traffic – but the surface is quite capable of taking the traffic that can cope with the gradient.

This is a durable route, flanked by a wall, thus reducing the visibility of users to others, and providing weather protection. It is known to have been used by MPVs for decades. It does not pass close to habitation, and the grazing sheep on the open fell are not alarmed by vehicles – and have ample space to move away. The route is in the North Pennines AONB, but not in a part that is heavily visited.

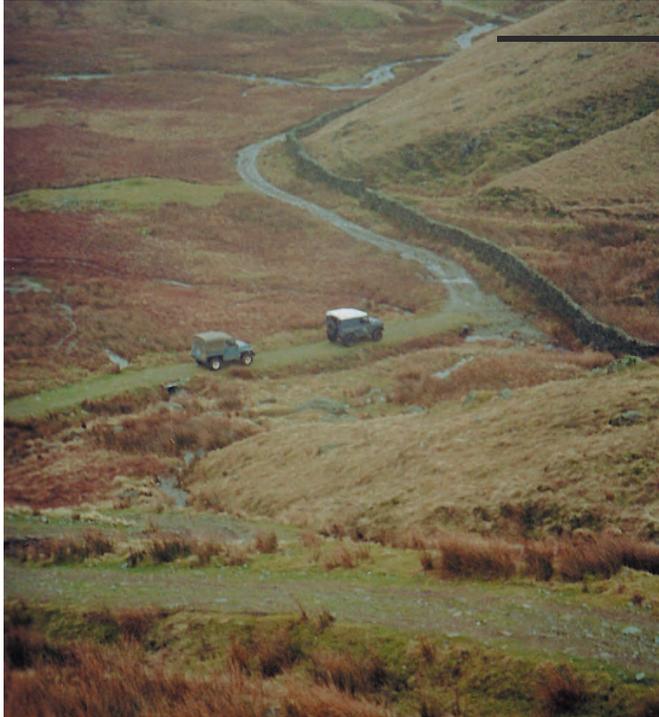
Grid reference 80/477087, looking northeastwards.

Gatescarth Pass links two of the Lake District’s most beautiful and remote valleys, Longsleddale and Mardale. The name itself implies a route: *gate/gata*, meaning street, way or path; and *scarth* implying a gap. It is generally regarded to be the old road north from Kendal to Scotland before the later turnpike routes were developed over Shap Fell. It climbs from both valleys in a series of well-defined dramatic zig-zags from heavily glaciated valley heads. Sections of the route are pitched and/or paved – a legacy from mining days. Summitting at 570 metres, it is one of the highest fell-top roads in the area, and is favorite route for walkers, mountain bikers and the bravest of horse riders.

After many years of no maintenance, during which sections of the route over peat became impassable and undefined, the route underwent extensive repair and maintenance in 2002. The route is now looked after by club volunteers. Following the repairs, the route has been used as a pilot exercise for a series of possible programmes for managing recreational motor vehicle activity in partnership with recreational motor vehicle clubs locally. The result of this collaboration is that use of Gatescarth Pass is now regulated by means of a permit system to use by a limited number of trail motorcycles and 4x4s on just one day each month. The regime acknowledges the sensitive nature of the location, the heavy use of the route by other users, and the historic nature of the route as a highway.

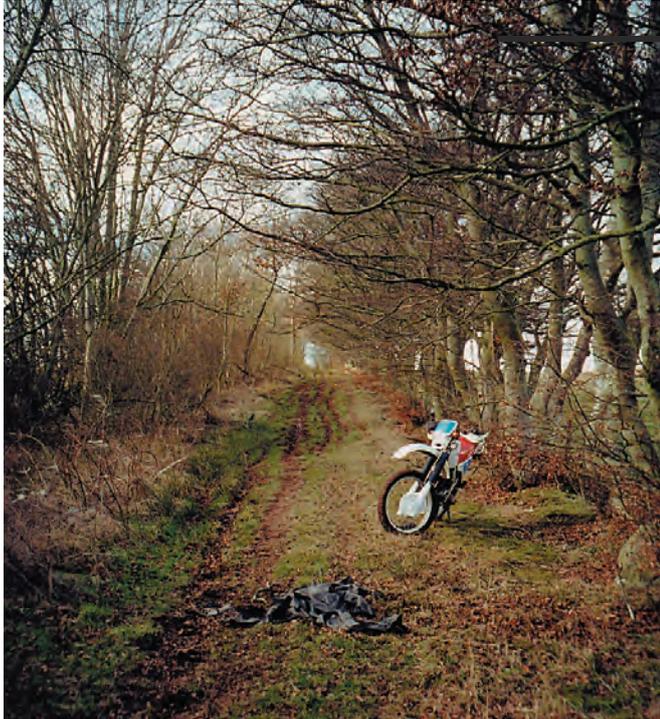
Grid reference 86/596403, looking north-northwestwards.

Viol Moor Public Carriage Road is a classic tree-lined forty-foot-wide green road in the Vale of Eden, Cumbria. The trees appear to be the natural evolution of the enclosing hedges planted when the road was set out. In parts, there are small trees and bushes blocking part of the width, but voluntary work by MPV users has cleared and drained the route to the point where it is now readily usable by walkers, cyclists and equestrians.

The centre strip of surface seems to have a sunken layer of stone, now with centuries of grassy deposit on the top. There is considerable agricultural use – which the road withstands, bar some localised rutting – and agricultural litter as evidenced in the photograph.

This route is well-made and durable. The voluntary work in recent years has improved the ability of the route to dry out by ‘sun and wind’, but the untrimmed treelines do inhibit natural drying. Because of this, users should inhibit use when the surface is very wet, and consider a joint management initiative with the highway authority to carry out some further trimming and clearance work.

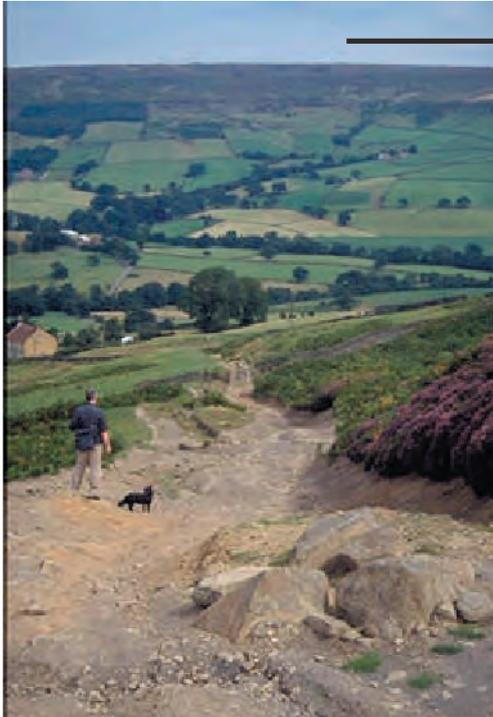
Grid reference 86/596403, looking north-northwestwards.

Monket Bank unclassified road in the North York Moors National Park, near Hutton-le-Hole. Pictured in 2000, the road had suffered from severe water erosion, a partial landslip, and wheel erosion by farm vehicles at the foot of the bank.

North Yorkshire County Council imposed a traffic regulation order prohibiting all vehicles (later revised to prohibit only MPVs) for safety reasons, and undertook a limited programme of repairs, allowing the TRO to be lifted altogether.

This route is based on part bedrock and part well-consolidated road stone. It is durable and does not get waterlogged in or after wet weather. It is therefore extremely durable for all types of traffic, but its location in a national park – albeit in a part that tends not to attract a lot of visitors – indicates a need for some sensitivity in use by MPVs.
