Ancient Road Conservation Volunteers

POCKSTONES MOOR PROJECT 2000

Report by Paul Sinkinson
DALETRAX LIMITED
01423-322011

ROUTE INSPECTION 11/12.04.00

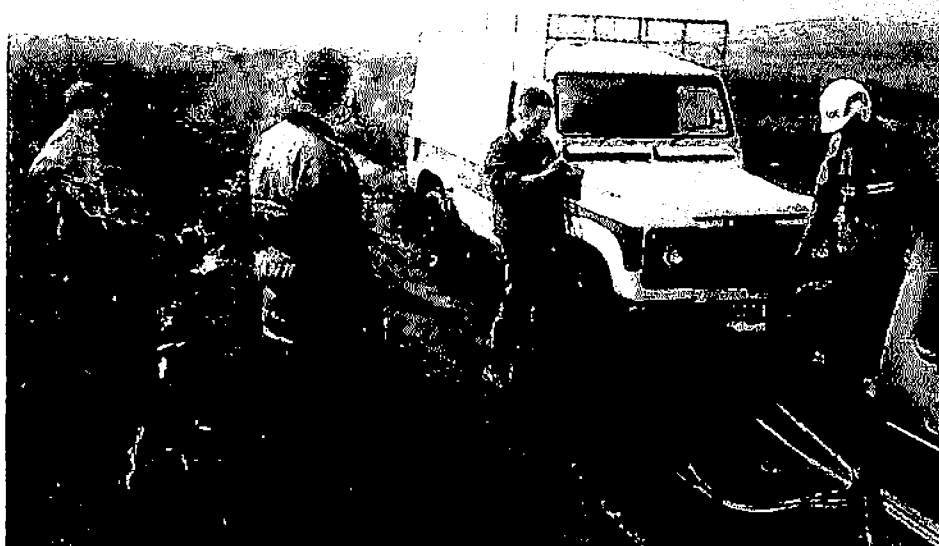
LOCAL TRAIL RIDERS FELLOWSHIP MEMBERS CONTACT A LOCAL 4 X 4 CLUB MEMBER WHO PULLS THE VEHICLE CLEAR OF THE ERODED SECTION - THIS WAS A "JOINT MANAGED SOLUTION"

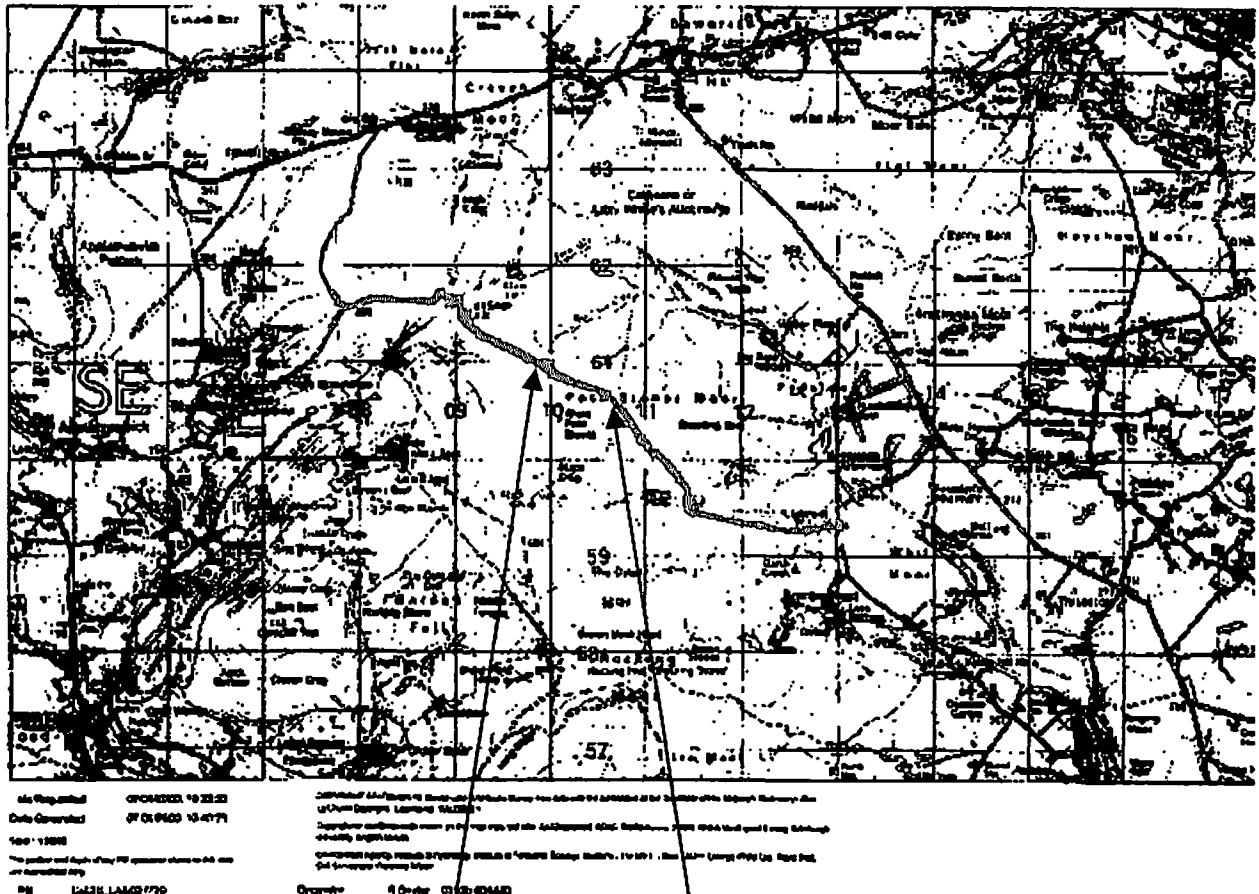
POCKSTONES MOOR PROJECT 2000 ROAD ROUTE MAP

The eroded section of road stretches between grid references
SE097610 & SE105607.

It can be seen from this illustration just how small this section is in
relation to the whole route.

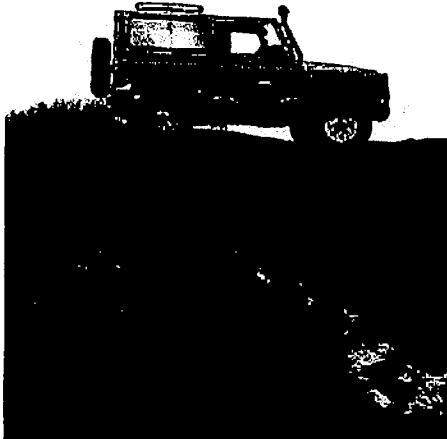
THE GOOD

The left hand picture shows a good working culvert on a well drained section between the "T" Junction and the eroded section. The ditches and culvert are both in good condition, providing a good dry road.

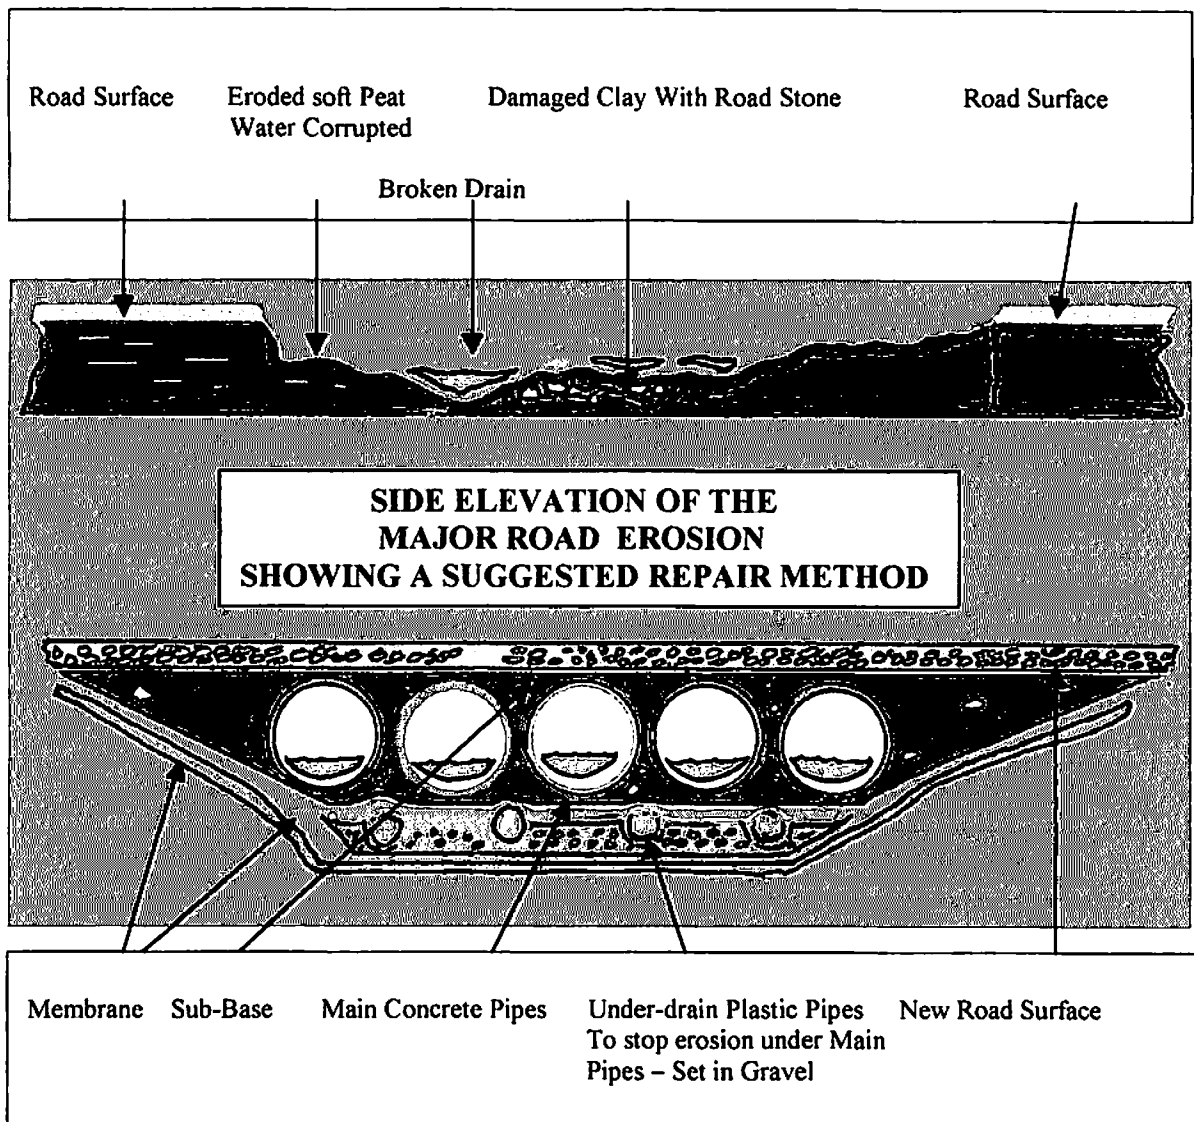
Computer generated sketch of finished repair with Dry-stone facia each side

The most cost and time efficient method of raising the eroded sections, ensuring future drainage and routing for the existing streams, would be to use concrete (or steel) pipe sections at 90 degrees to the road, spanning its total width, forming a miniature multi-arch span. The Water and the Council Authorities may already have a number of these surplus to requirements and possibly already accounted for in other previous projects. If this were the case, the supply of these would therefore only incur the cost of delivery. (Early indications show that this may be the case). These pipes are easy to move and install and reduce the amount of Bulk deliveries of Sub Base materials which would reduce the wear and tear on the approach route and, the amount of traffic through the local area.

The Main pipes would span the road over a membrane and gravel base, possibly under-drained with smaller plastic pipe work to deter the possibility of being undermined by excessive flooding. The road surface would be laid over the pipes on a membrane if this was thought necessary. Each side of the newly installed road section could be finished with a dry-stone wall effect to blend into the surroundings.
